Executive Summary Report
ASTERRA Satellite Leak Detection
2023-2025 Review

North Kingstown, RI
October 2025

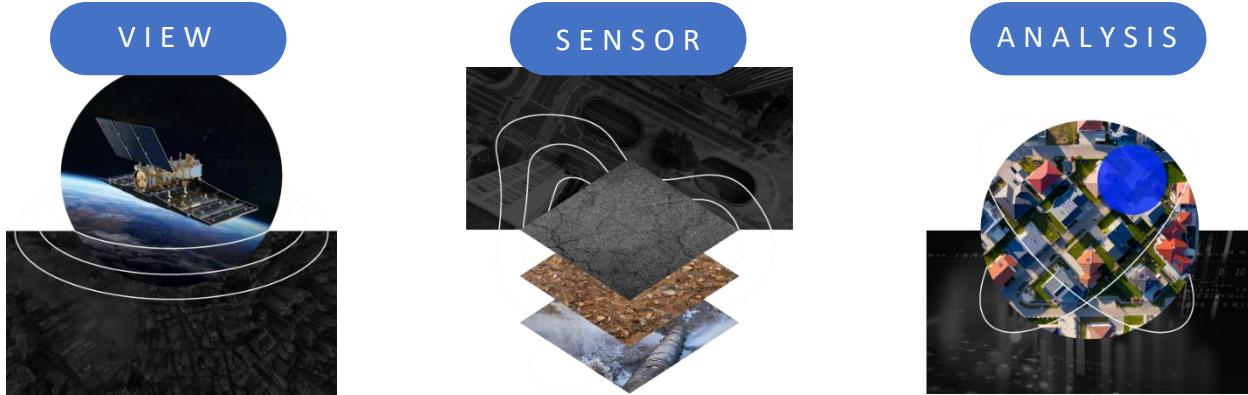
ASTERRA utilizes specialized radar signals taken from a satellite to scan the area of interest and collect the resulting reflected signals. These signals are analyzed and processed to identify specific indicators of wet soil saturated with potable water, screening out the signal noise and other interferences. The result is a map showing points of interest. The ASTERRA analysis typically highlights 5-10% of the entire system length, and only these locations, where there is expected to be a leak, are inspected by BOTG leak detection teams. Thus, the time and resource cost of leak detection is much lower than traditional leak detection approaches (e.g., full-system, random, systematic, or block map).
