Recommended Actions Summary

Town of North Kingstown, RI

The [Wood-Pawcatuck watershed](#) is vulnerable to flood-related damages, as evidenced by the devastating flooding that occurred in 2010. The Wood-Pawcatuck Watershed Association, working with the watershed municipalities and partner agencies, has developed a [watershed-based management plan](#) to enhance the resiliency of the watershed communities to future flooding and protect river and stream ecosystems, including water quality and habitat. The following is a [summary of key findings and recommendations](#) of the watershed plan for the Town of North Kingstown.

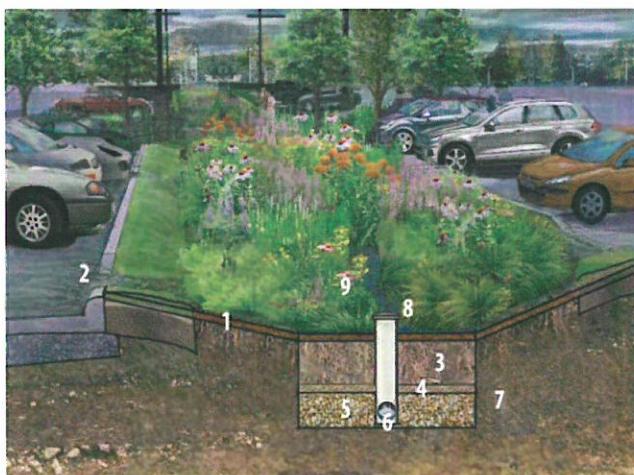
Rendering of a typical bioretention area

No site-specific GI retrofit concepts were developed for North Kingstown due to the town's small land area within the Wood-Pawcatuck watershed and the limited scope of the GI assessment. The Town should incorporate GI approaches into municipal stormwater infrastructure planning and capital improvement plans to address drainage, flooding, and water quality priorities including MS4 Permit requirements, both within and outside of the Wood-Pawcatuck watershed. GI can be implemented on public sites including municipal parking lots and within the public right-of-way.

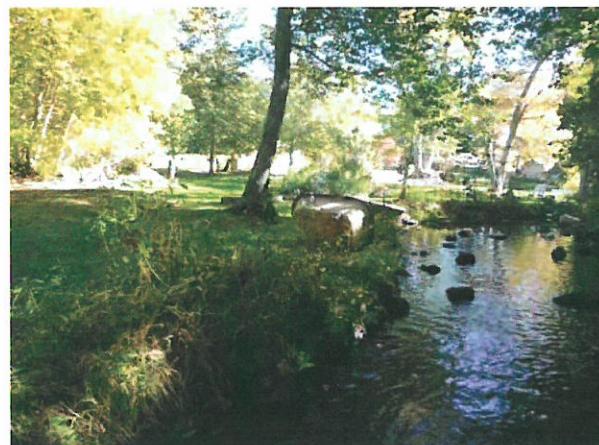
Proposed area of riparian plantings where residential properties are located on the left bank of the Chipuxet River

Between Slocum Reservoir Dam and area downstream of Railroad Road (Chipuxet River)

- Encourage riparian plantings along the left bank of the river where residential properties abut the channel, to reduce risk of erosion and promote high quality habitat
