Brown Street, Wickford Village Design Standards and Guidelines

**Town of North Kingstown, Rhode Island
Adopted September 24, 2018
Final Version**

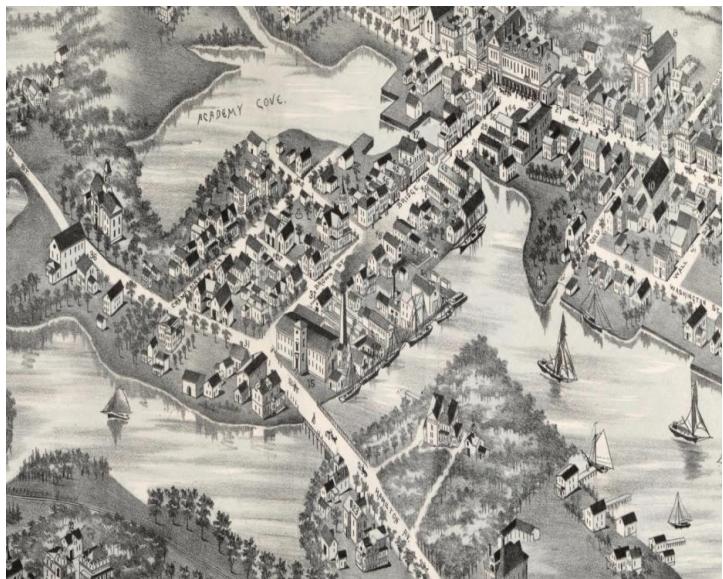
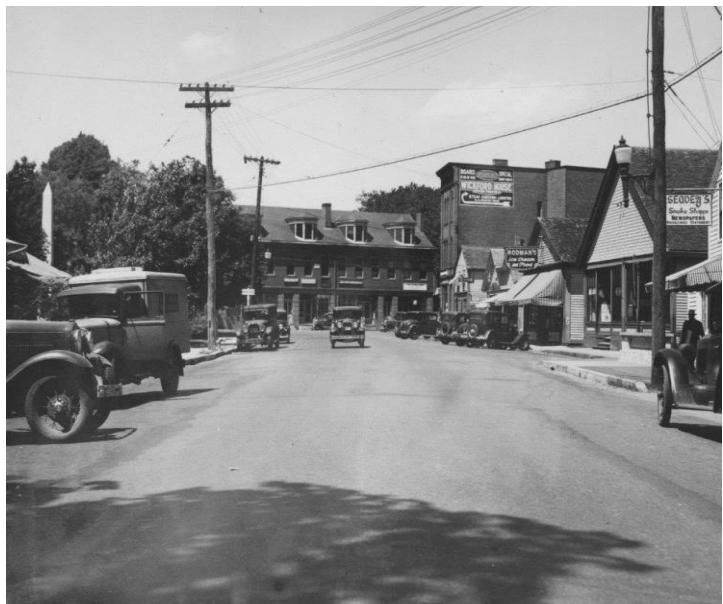
Historic views of Brown Street such as the bird's eye view above from the late 1880s and the photo below from the early 20th century help illustrate the architectural character of Brown Street.

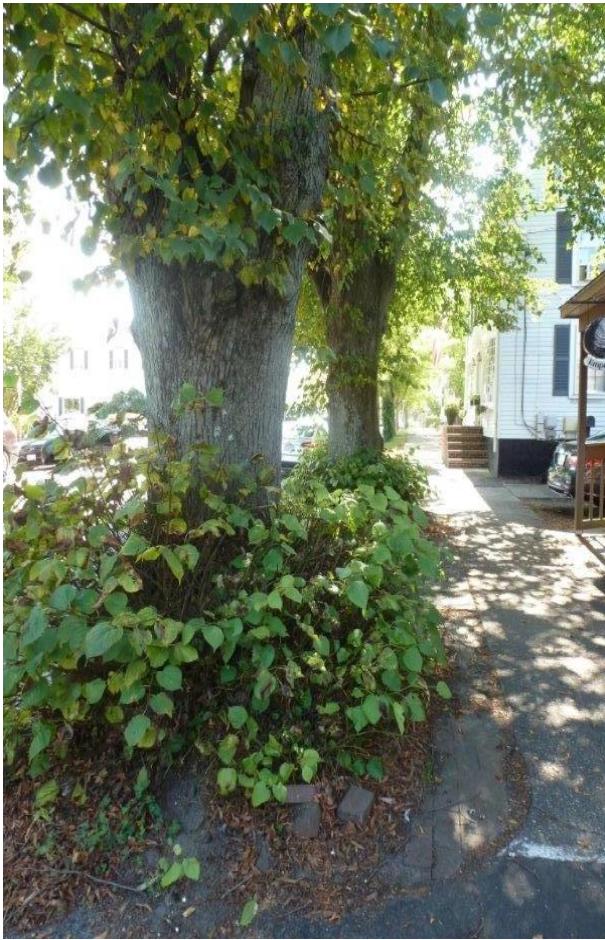
Ancient street trees with roots that have spread into the sidewalk are character-defining but a potential hazard.

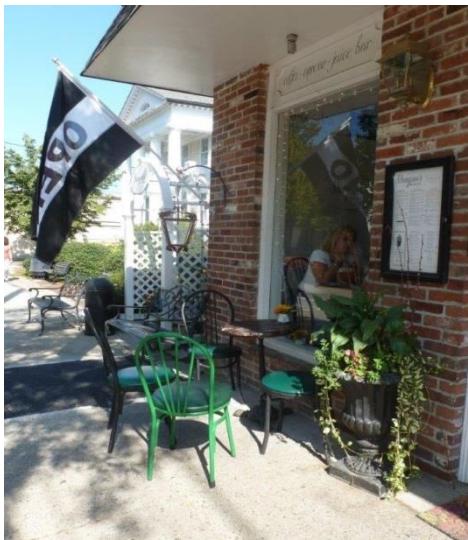
Site furniture with appropriate scale and placement benefits the front of a restaurant.

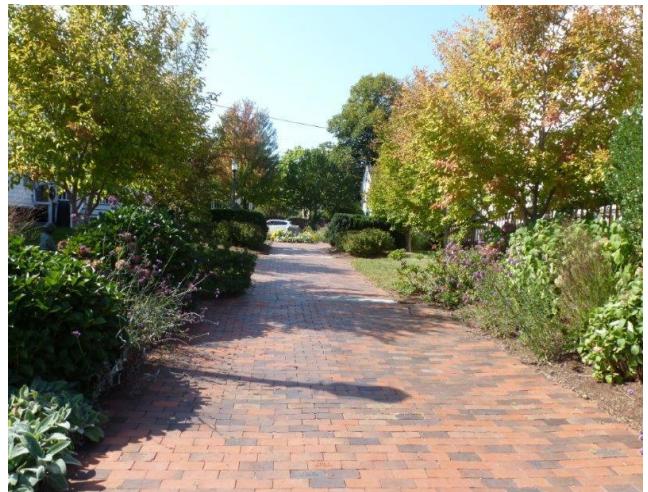
Careful selection of pavement and plant material fit the character and scale of the village and provide an attractive and safe public way.

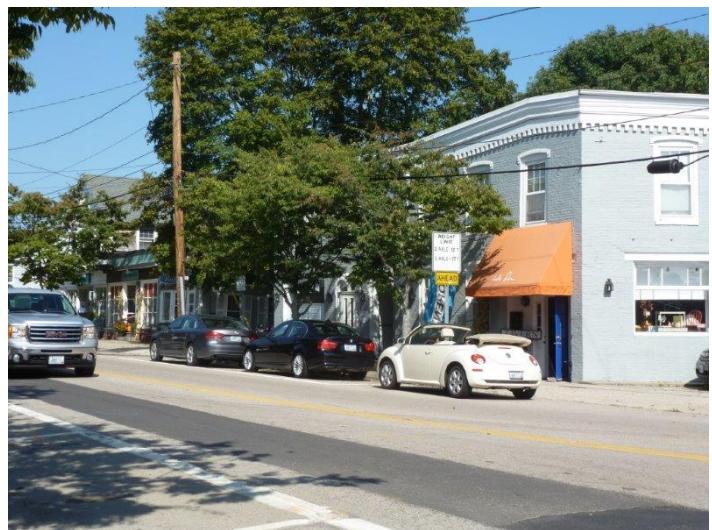
Street trees along the east side of Brown Street are in conflict with, but partially conceal, the overhead utilities.

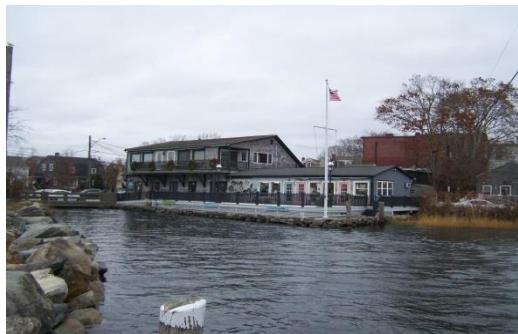
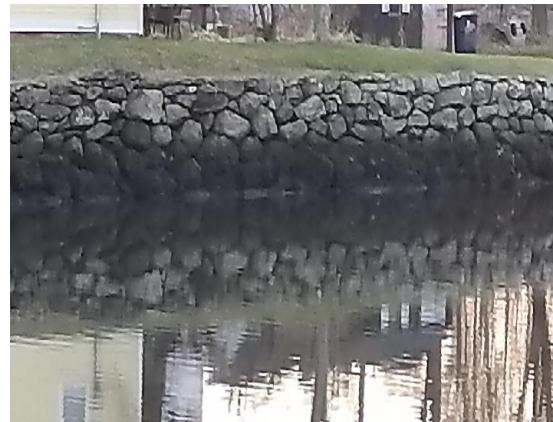
Rip-Rap Bulkhead

Rip-rap bulkhead treatments can be found along portions of Wickford Cove. They also exist along the northerly bank of the inlet leading out from the Kayak Center into Academy Cove. This type of treatment protects the shoreline from erosion and provides stability for any nearby structures such as docks.

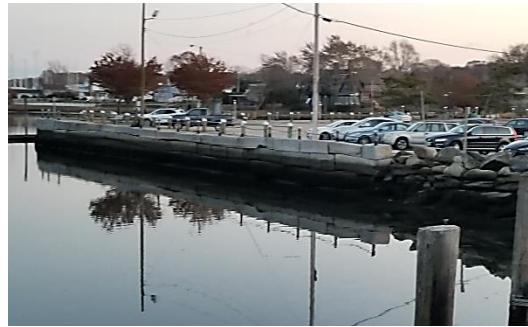
Concrete Bulkhead

Concrete bulkhead treatments are located along the southern side of Wickford Cove from the Hussey Bridge traveling north towards the municipal parking lot. They are also on either side of the inlet between the municipal parking lot and the building block of the Beach Rose Cafe. These concrete walls also protect the shoreline from erosion and provide stability for nearby structures, docks and buildings.

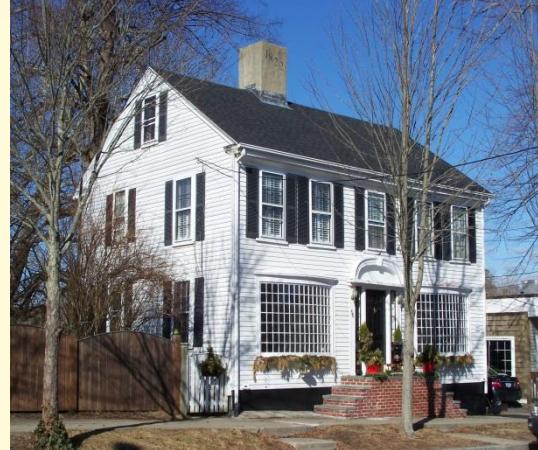
Federal: 1790-1820, gable and hip roofs, 6/6 wooden windows, central brick or gable end chimneys

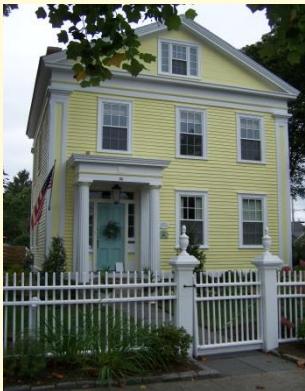
Greek Revival: 1830-1850, gable roofs, pediments, corner pilasters

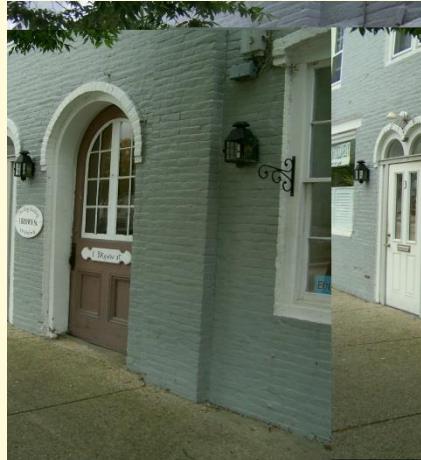
Italianate/Mansard: 1850-1880, roof brackets, round-arched window hoods, 2/2 wooden windows, flat or mansard roofs

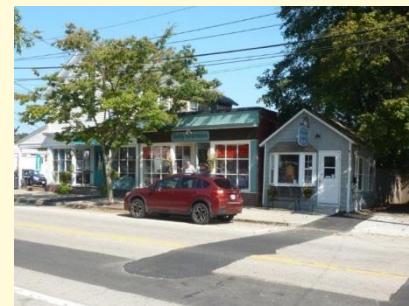
Vernacular: small scale store fronts 1880 - 1950

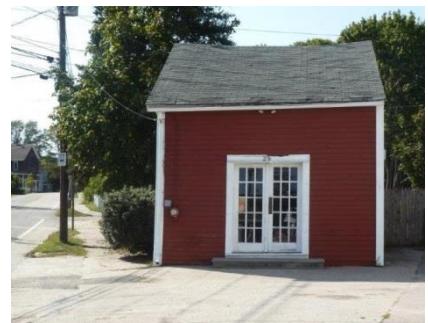
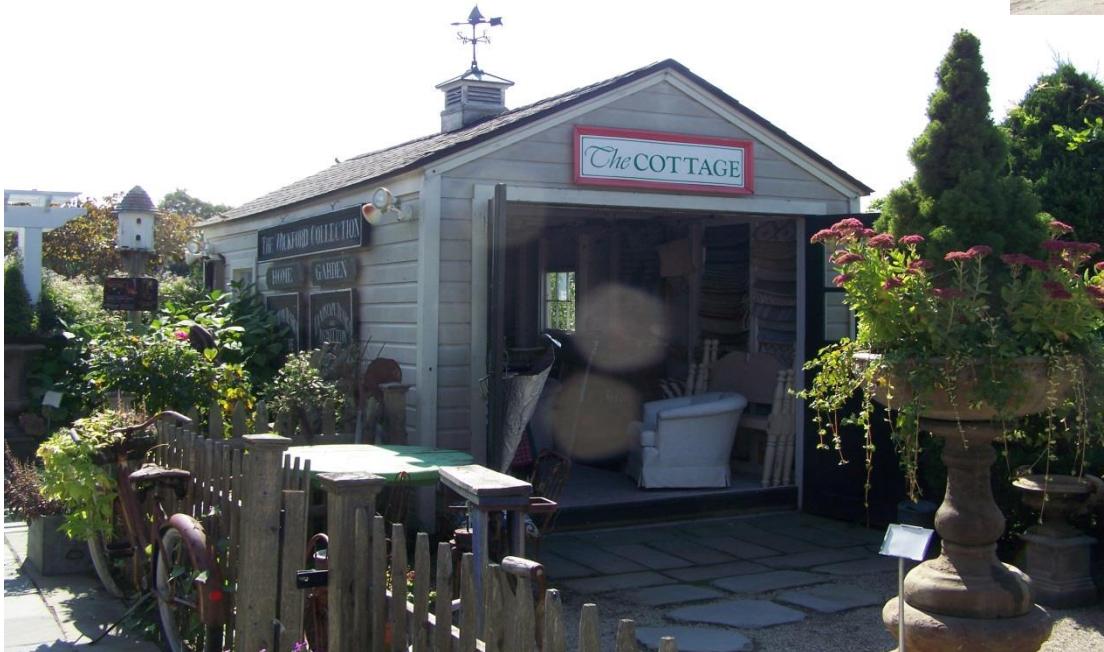
Accessory buildings in the Brown Street area have been successfully converted to commercial use in the past.

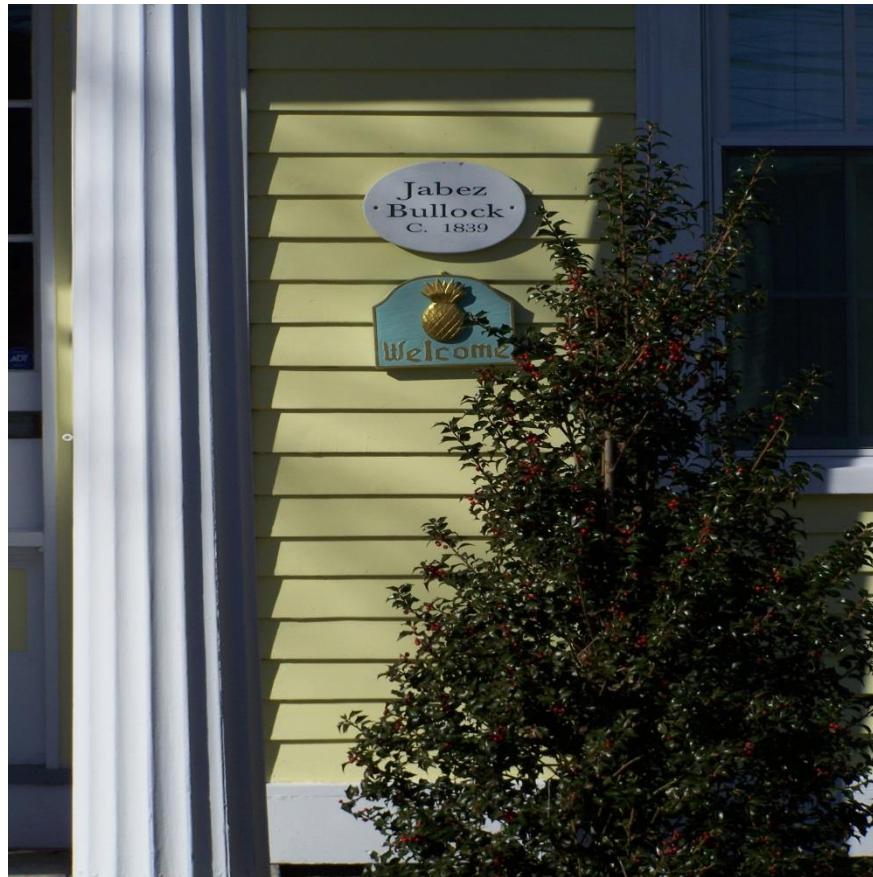
On close inspection, vinyl siding applied on the building at right does not convey the same visual appearance as the wood clapboards above.

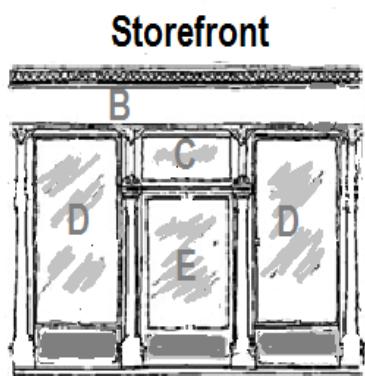
Storefront

- A A Cornice
- B Sign Board
- C Transom
- D Display window
- E Recessed entry
- F Piers

In terms of preferred locations, for commercial buildings wall-mounted horizontal signs should be located above the store front windows and entrance on the sign board frieze, which is a wide horizontal board found on traditional storefronts above entrance and display windows.

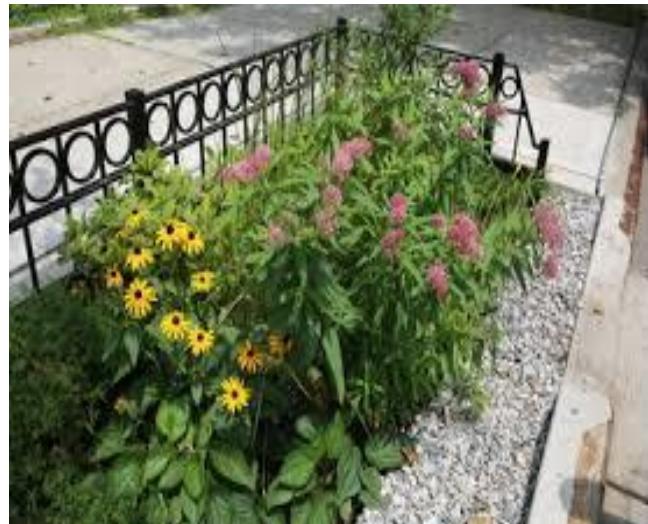
Rain gardens for a small scale urban places can aid runoff control.

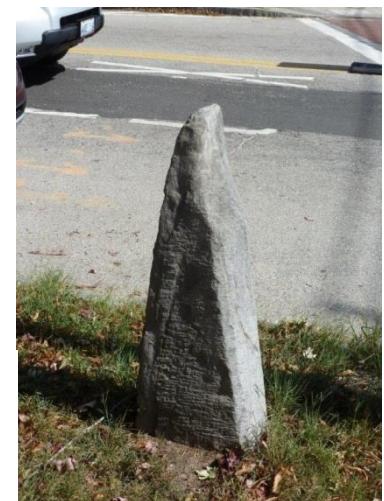
Remnants such as this old stone hitching post should be retained.

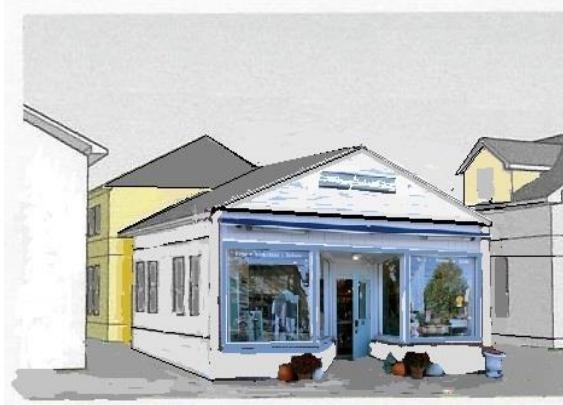
Appropriate – putting addition behind historical building with connecting hyphen

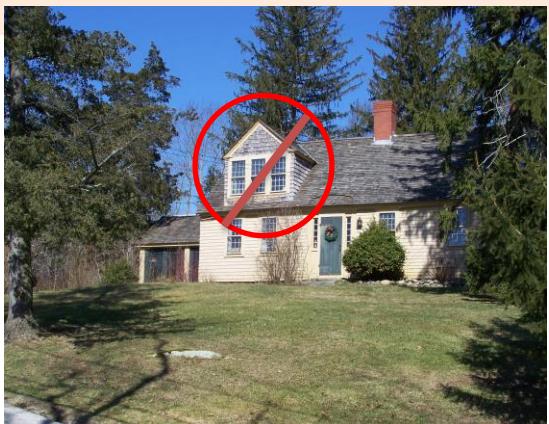
APPROPRIATE ADDITIONS to small single story historic buildings

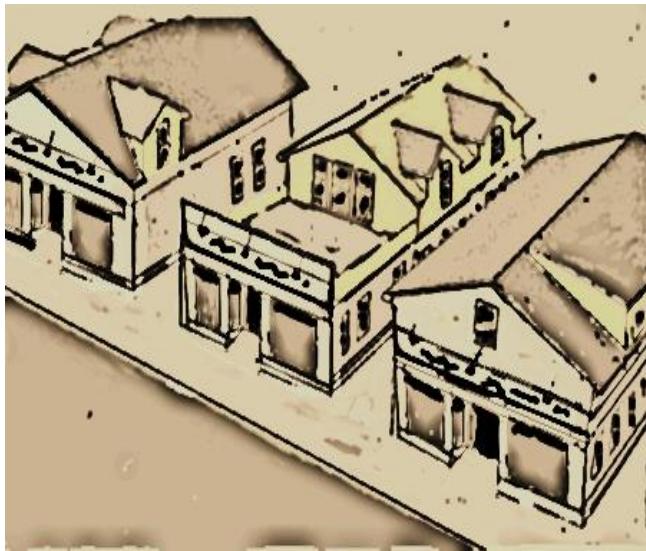
Highlighted in yellow are appropriate second story additions. The center one is set back from the front façade parapet. Appropriate dormers have been added to the adjoining buildings to provide second story space. These additions are in scale with the original building and do not intrude upon the streetscape.

At right in yellow an appropriate new rear two story addition has been added to the original building with a small single story hyphen connector. The addition is set back and differentiated from the original store and store

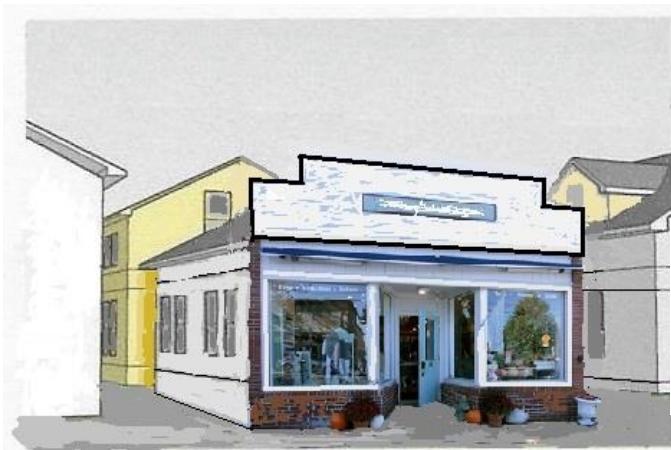
To the left the addition in the above illustration is shown from street level. The new portion of the building does not change the Brown Street façade and its small scale character, yet considerable space is added to the building.

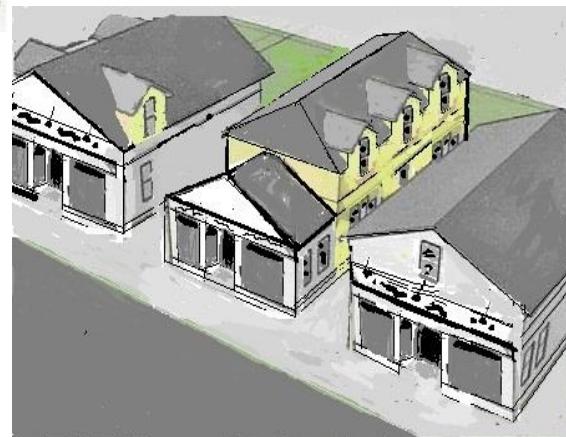
To the right in yellow is a two story addition to a small single-story gable-roofed building. The addition is large, but the impact is diminished by setting back the second story from the single story façade and providing a hipped roof. As in the illustration above, the character-defining small scaled commercial street front remains intact when viewed from the street.

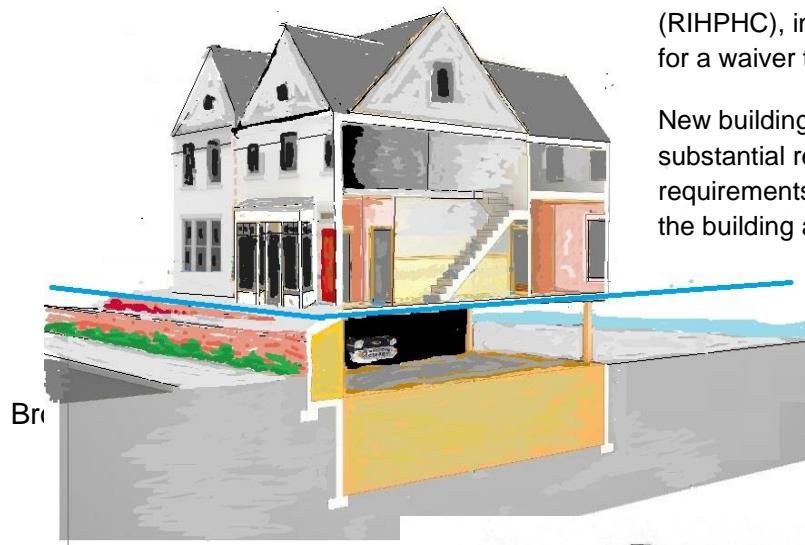
The new building design to the right demonstrates that flood code requirements and two stories of mixed use space can be accommodated within the height limit, including access ramping and dry flood proofing of the commercial first floor.

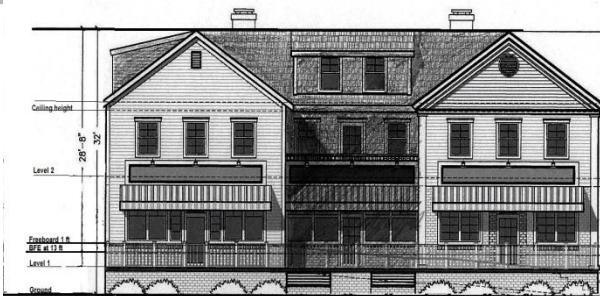
This new building is elevated over three feet from the ground level at the street. Dry flood-proofing of the first floor commercial space to the window sills accommodates the base flood elevation and required freeboard. A flight of stairs and a ramp provide access from the sidewalk in front of the building.

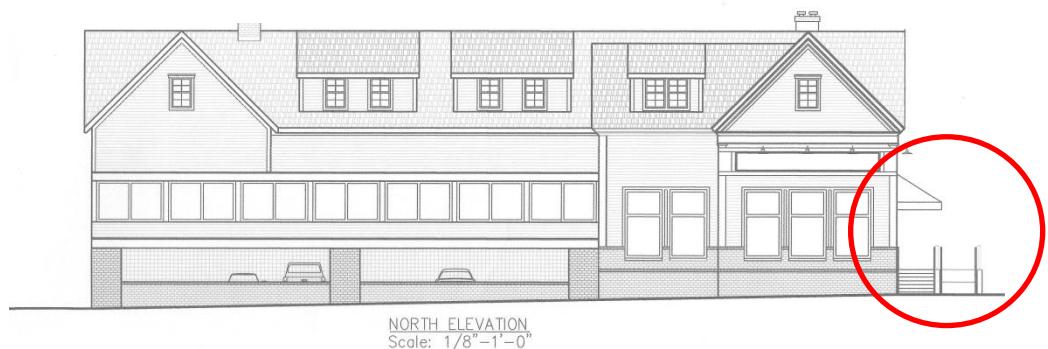
Parking underneath the building with access from the rear is shown below in a side view. The ramp in front of the building is circled in red.

Most of Brown Street lies within a flood hazard zone due to its coastal location. The contributing buildings of Brown Street are eligible for waivers from strict flood code requirements, but every effort should be made for resiliency in a rehab project to reduce future insurance costs. Projects must be reviewed and approved by the RI Historical Preservation and Heritage Commission (RIHPHC), in conjunction with the local building official for a waiver to be granted.

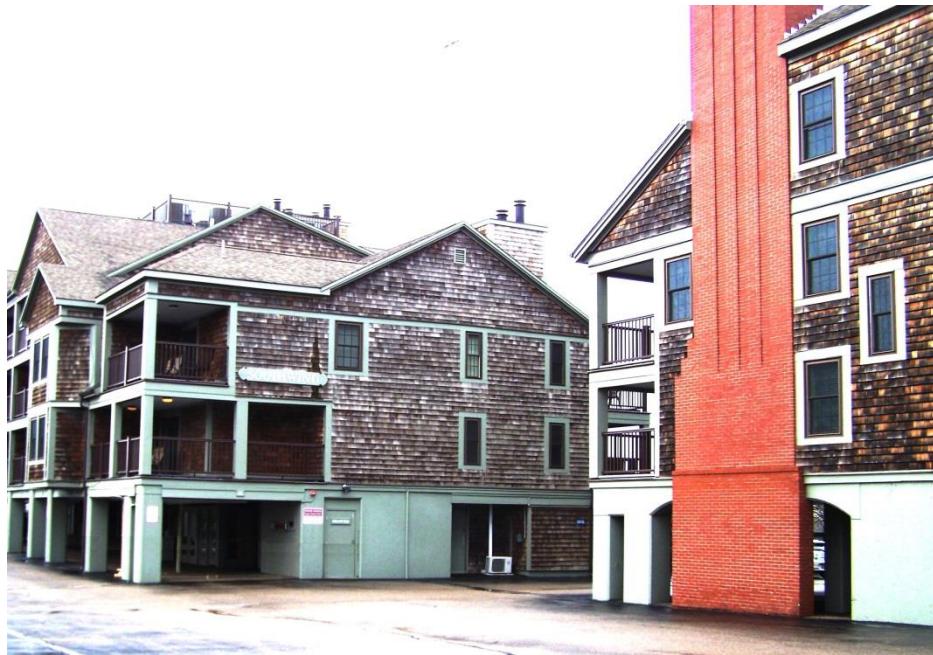
Parking beneath a new building accessible from the harbor side (as shown above and below) is possible for locations on the east side of Brown Street due to elevation changes. New Brown Street commercial fronts, although elevated to meet flood code requirements can also be accessible to pedestrians as shown on the preceding page and on page 40 (at end of page).

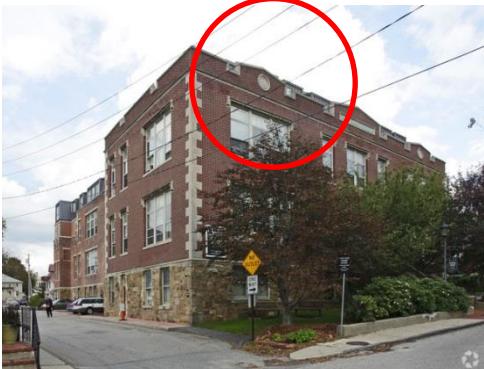
To the right the rooftop addition is concealed by a parapet.

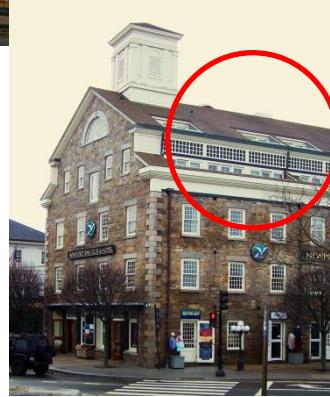
To the left, the addition is set back with a roofline that complements the original.

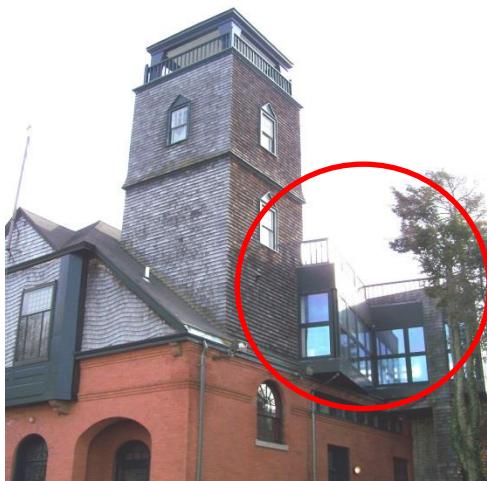
To the left, roof space is reused for housing with set-in balconies that continue the roof form and allow reuse.

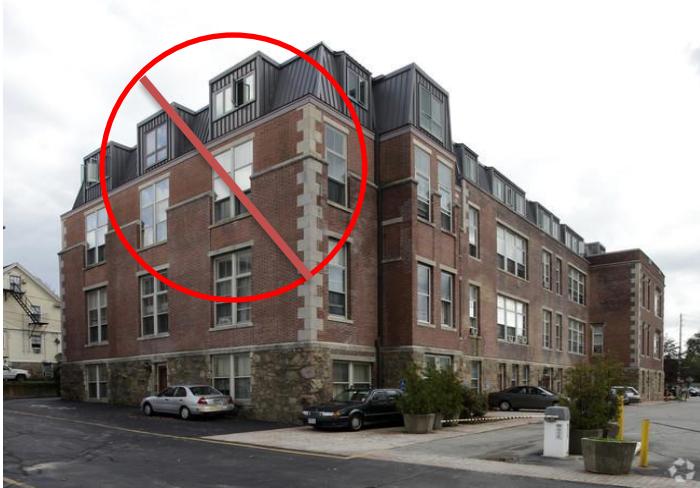
Additions and New Buildings that are Not Appropriate due to design and scale

The additions and alterations above and to the left are not in scale with the original architecture. They overwhelm the building in both cases and appear as incongruous.

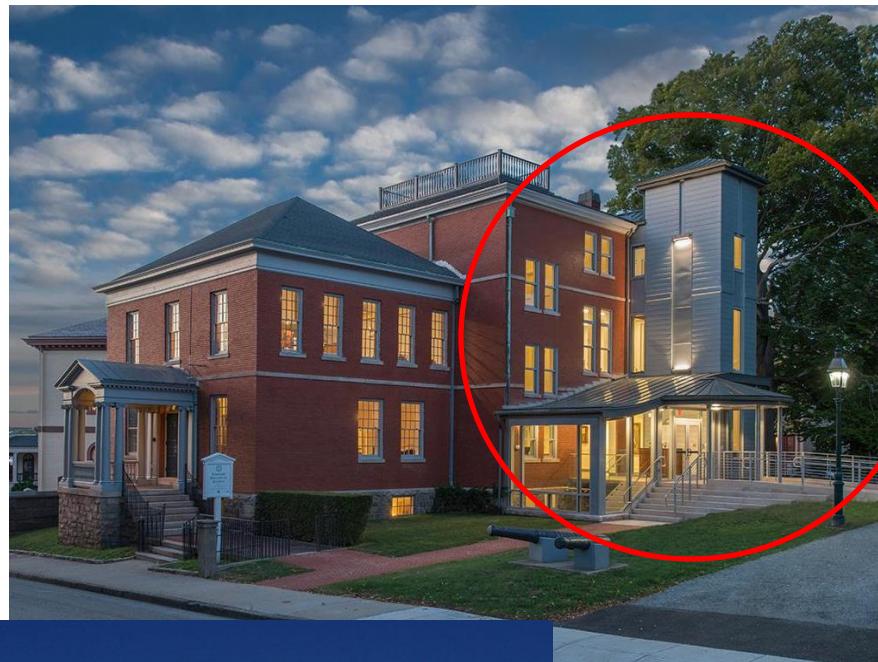
The addition above was made to create a new ADA entry and elevator.

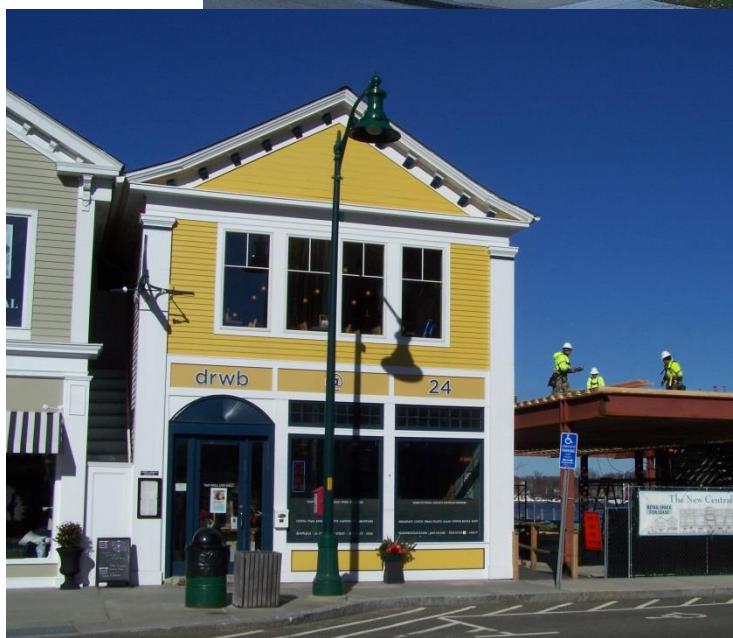
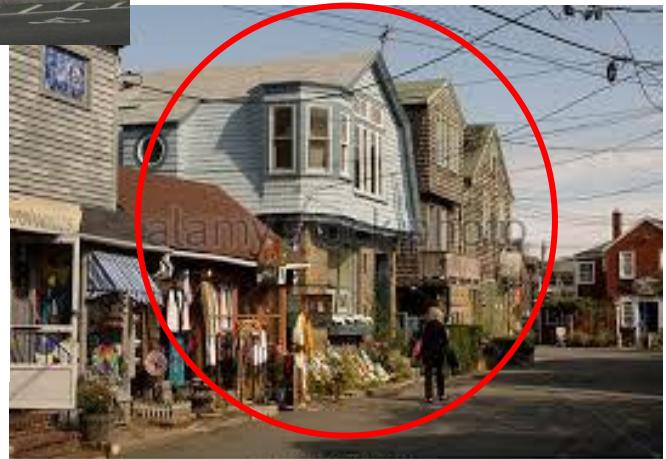
To the left, a new building blends with a historic New England Main Street. Simple details identify the building as new infill.

To the right, new mixed use residential/commercial buildings grace a New England coastal village.

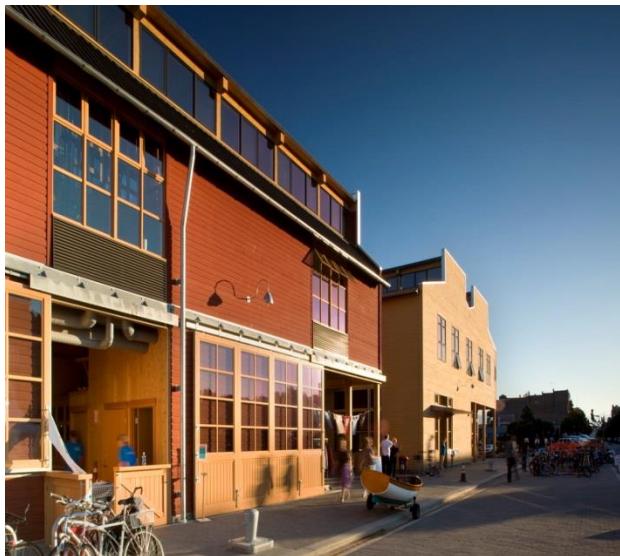
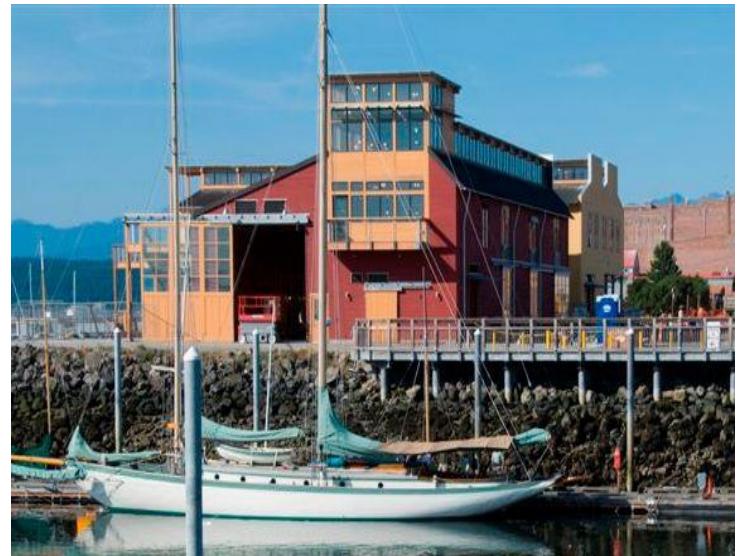
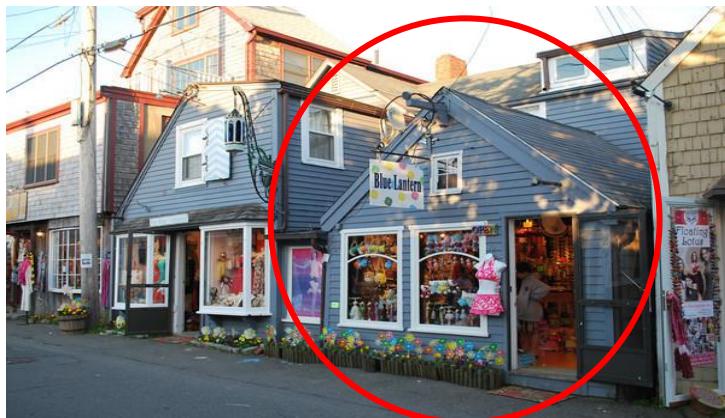
Above are new buildings located in a coastal flood hazard zone with parking possibilities on the ground level.

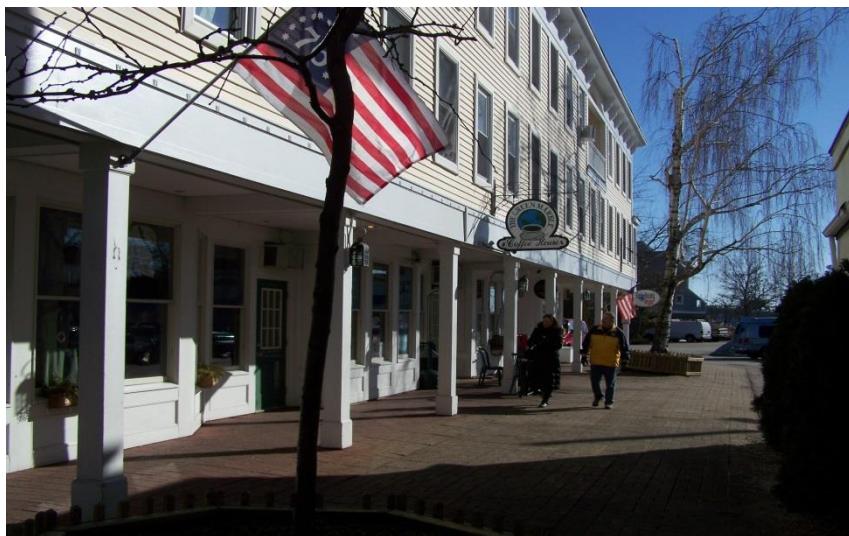
To the left (center) is a new mixed-use building that blends with the adjacent Main Street in a coastal New England village.

To the right, new residential wharf buildings with dry flood-proofed ground level retail and office uses. Residential uses are above.

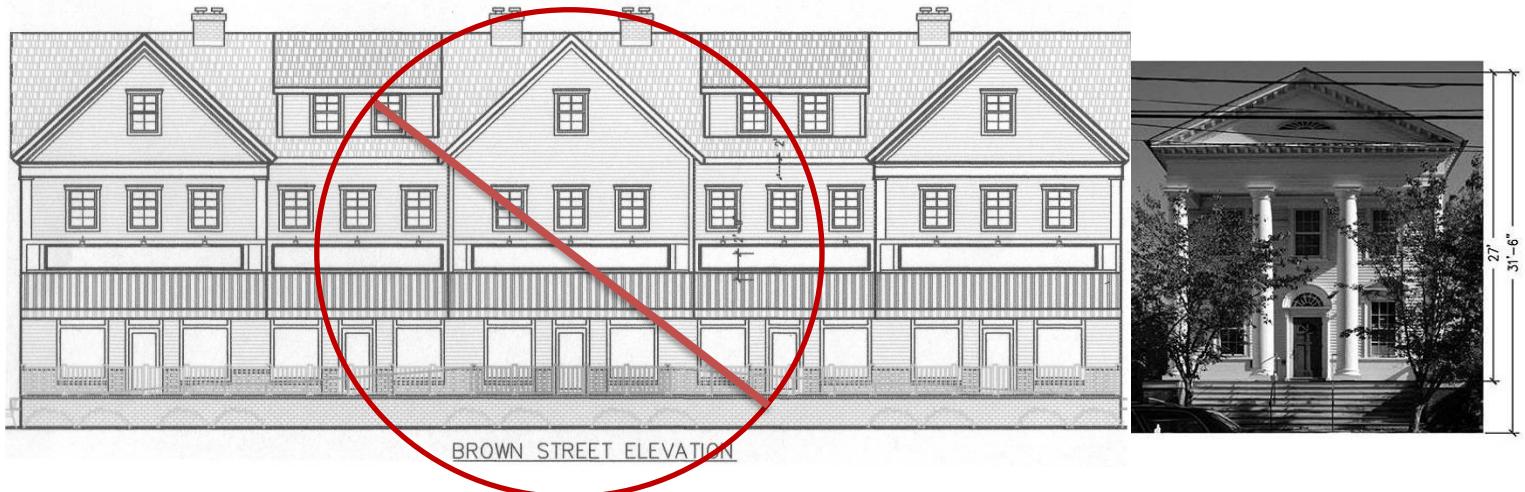
The proposed new building above is completely out of scale with its existing iconic Brown Street neighbor to the right. New buildings with large footprints should be broken into smaller facades which are similar in width to the existing historic facades on the street. (See Guideline #61-63.) Although too tall and massive, the new project above attempts to mimic the façade width of other buildings on Brown Street. The rhythm of windows and storefronts also matches and projecting gables are also employed. The overall scale of the building, however, is not appropriate. The building would stand out and be out of scale with the Brown Street area.

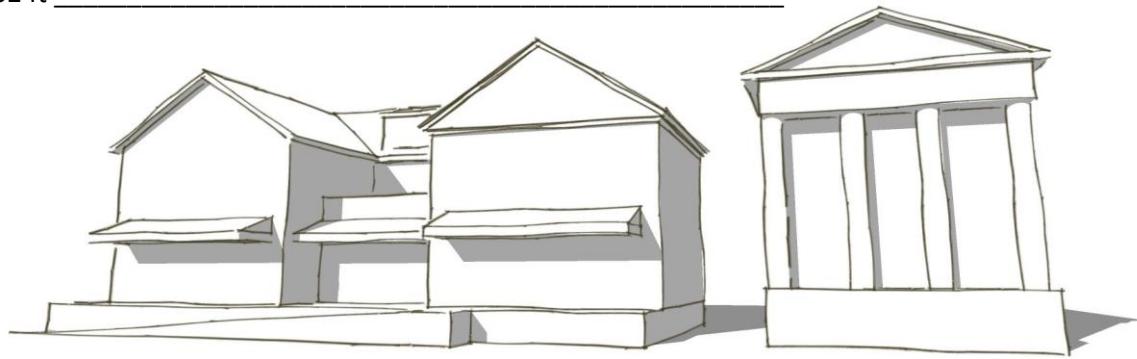
32 ft

Above is an appropriately scaled and elevated new building designed to accommodate the flood code and be no taller than the historic building on the right. Per Guideline #61, the iconic historic North Kingstown Library building (on the right) remains prominent in the streetscape.

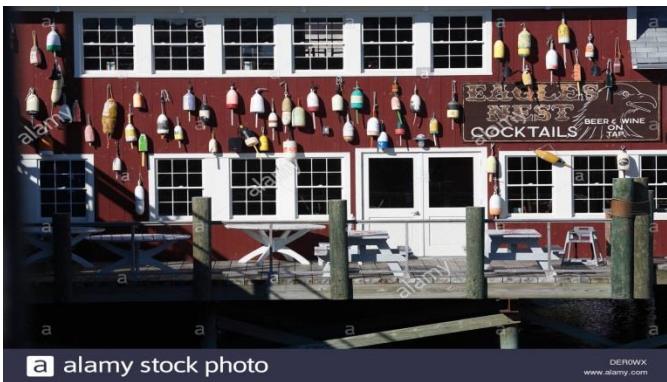
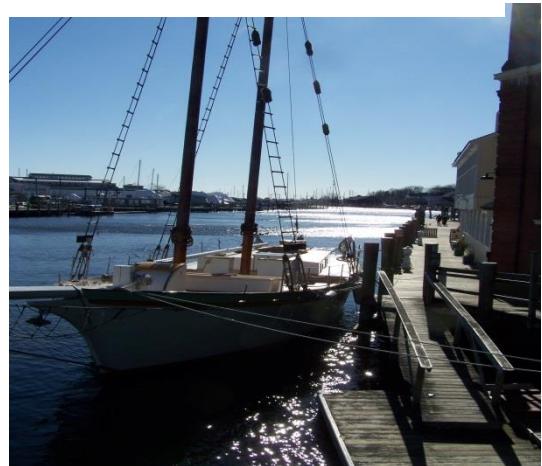
The waterfront offers additional areas for renovations and new buildings. The 1880s bird's eye view offers some design direction (see Sections 4,5,6).

A public walkway along the entire area from the Hussey Bridge to the Brown Street bridge is desirable. It should have a wharf-like appearance.
